Sandwich building panels and battery chargers do not mix well

Report published by
Allianz Risk Consultants

Meat processing for large and medium-size supermarkets

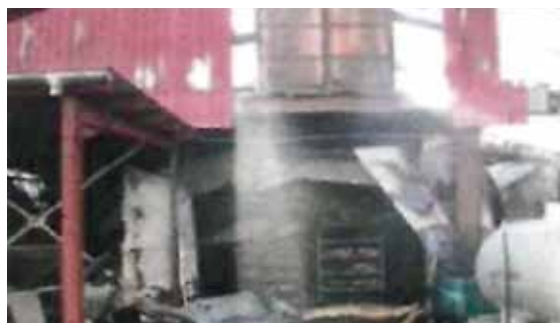
- A few rooms with concrete walls and an outdoor gas tank were partially spared from the flames due to their fire-proof construction and to the quick and massive intervention by the firemen.
- The existence of a contingency plan enabled production to be partially resumed in a short time at a temporary site. This involved additional costs.

↑ Gas tank, intact amid the rubble

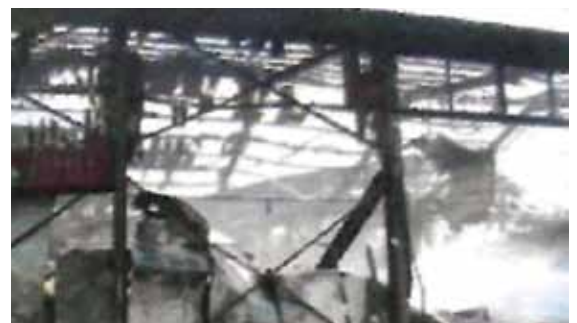
- The fire rapidly spread to the entire plant. The building (metal frame, exterior walls and inside partitioning - all made of combustible sandwich panels, and the roof - made of cement-asbestos panels), as well as the inventory and equipment, were totally destroyed.
- Following the fire, total shutdown of production that lasted 2 months. Operations were then partially resumed at a temporary site.

- The presence of sandwich panels with a polyurethane and styrofoam core. These substances are highly combustible and difficult to extinguish due to their location between two metal sheets.

- Very thick, toxic fumes caused by the combustible sandwich panels.

↑ Burnt-out building

- As much as possible, panels with non combustible cores should be used. The former French "M" classification system for fire-resistance categorized these panels as M0. The new European classification system ("Euroclasses") categorizes these panels as A1 or A2.

- Given the major amount of combustible matter (sandwich panels, polystyrene packaging, etc.) present, an automatic sprinkler type system is the best means of protection for this sort of production activity.
