Sandwich building panels and battery chargers do not mix well

Report published by
Allianz Risk Consultants

Meat processing for large and medium-size supermarkets

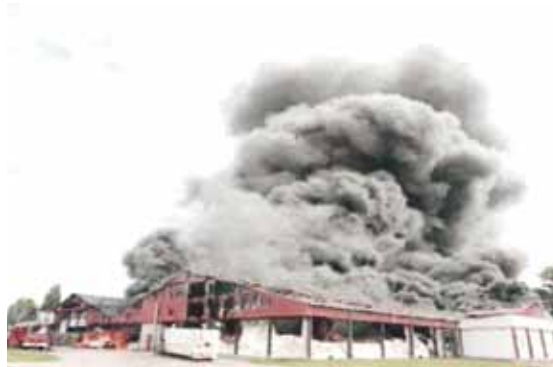
- Very thick, toxic fumes caused by the combustible sandwich panels.

↑ Burnt-out building

- If the use of combustible sandwich panels (French Class M1-M4 or Euroclasses B-F) is inevitable due to operating conditions, the specific provisions of the French Technical Document D14-A must be rigorously applied. This standard was developed by the French Insurers' Association and describes the installation regulations to be followed, as well as precautions to be taken with equipment layouts (especially electrical).
